Report on Vibratory Stress Relief

Prepared by Bruce B. Klauba
Product Group Manager

CAMERON COMPRESSION SYSTEM DIVISION

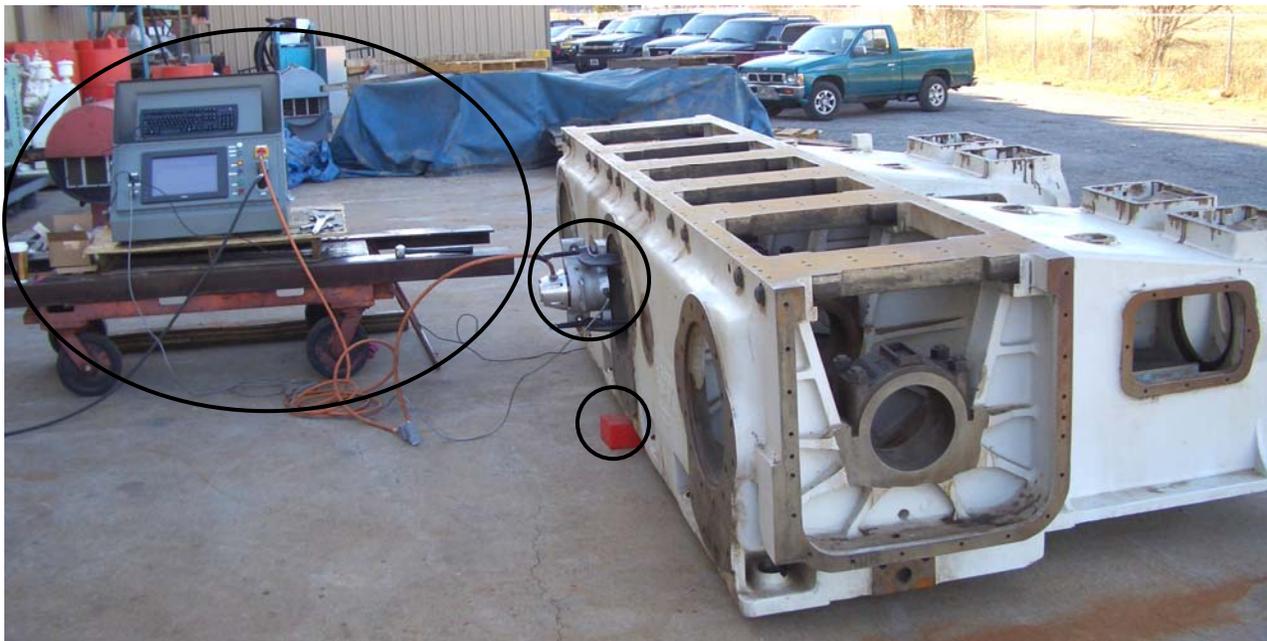
Figure 1: Compressor Frame setup for VSR Treatment. One Isolation Load Cushion (circled) is centered along continuous (non-gap) side of frame. The Vibrator (circled) was mounted above it. MX-8000 Console with touch-screen PC and USB keyboard visible on the left (circled).

Each Frame was placed on 3 Isolation Load Cushions. One Load Cushion was placed at the center of the long continuous (opposite the "gap") side, (*see Figure 1*). The other two Load Cushions were placed on the opposite long side, on either-side of the 20" gap (*see Figure 2*)

The Vibrator was clamped securely to the workpiece near the center of the "continuous" side (*as shown* Figure 1), and oriented so its Axis of Rotation (AOR) was horizontal, and parallel with the minor axis (width) of the workpiece. Other orientations were tried, but this orientation was found to generate both the greatest number and the highest intensity resonances, without causing peaks in the power curve – evidence that the Vibrator is well-positioned and oriented. An incorrectly located Vibrator or one adjusted to excessive unbalance results in large peaks in the power curve, which can trigger the VSR System's motor protection.

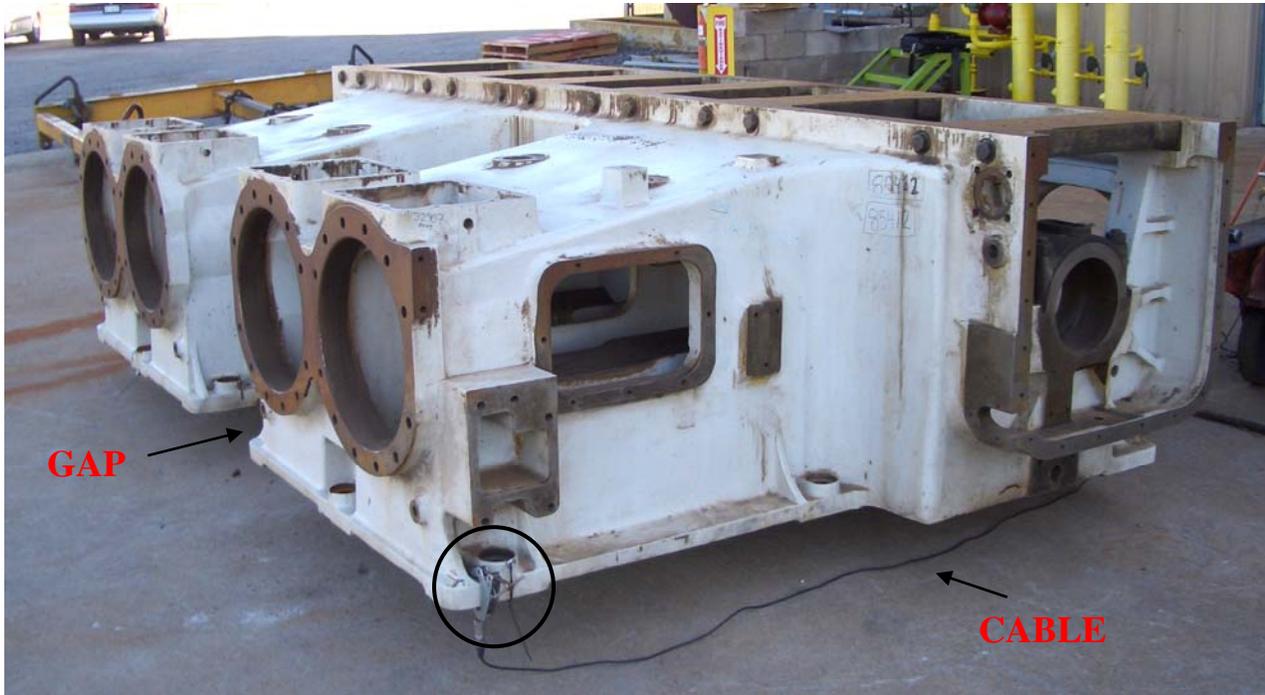
Figure 2: "Gap" side on left is ≈ 20 ". A Load Cushion was placed on each side of the gap (not visible), about 12" from the outer edge of the Frame. The Accelerometer can be seen in the foreground (circled), with its connecting cable leading to the VSR-8000 Console.

An Accelerometer (sensor whose output is proportional to acceleration), was placed on a corner of the workpiece, far from the vibrator, so as to best detect resonance. Based on Newton's 2nd Law, $F = ma$, where F is force, m is mass, and a is acceleration, acceleration has repeatedly shown to be the best parameter to gauge workpiece amplitude.

A second Treatment was performed, with the Accelerometer repositioned and reoriented. After testing a few different locations and orientations, an ideal Accelerometer location was found directly above the one shown in Figure 2, and the sensor was oriented so as to be sensitive to amplitude in the direction of the workpiece's major axis (length of workpiece). This new positioning yielded better resonance data for the higher RPM resonance frequencies located at 5000, 5600, and 5800-RPM (*see Figure 5*). Note that the large resonance shown in Figures 3 & 4 is much shorter in Figure 5.

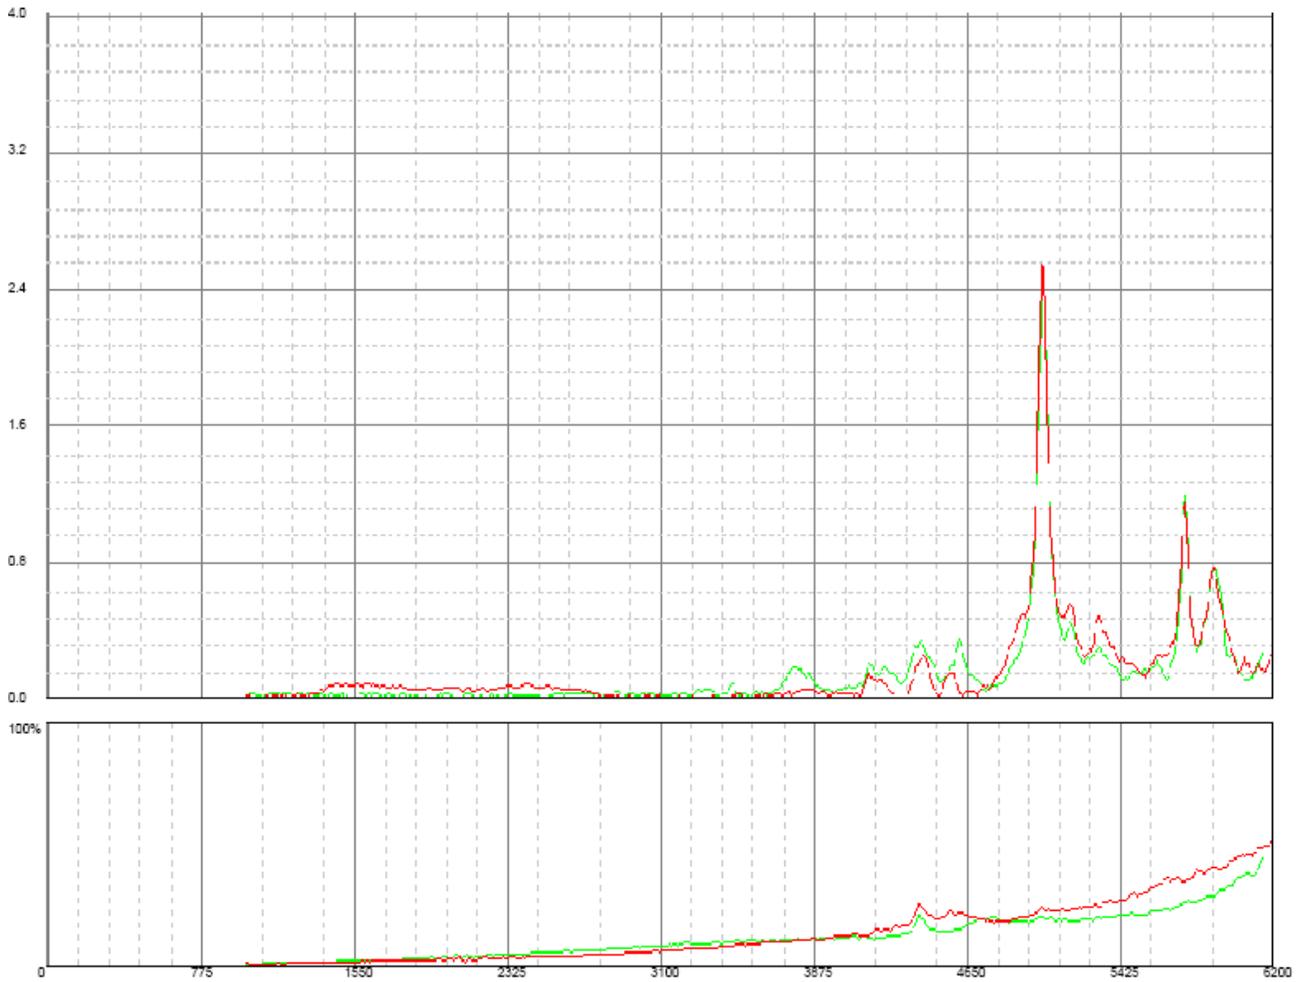
Figure 5: Workpiece 1, Treatment 2. Relocation and re-orientation of the Accelerometer enabled high RPM peaks to be easily detected. However, little peak growth or shift took place, as evidenced by the similar Pre- and Post-Treatment Scans.
